# Dangers of Purging Gas Piping and Recommendations

# Dangers of Purging Gas Piping

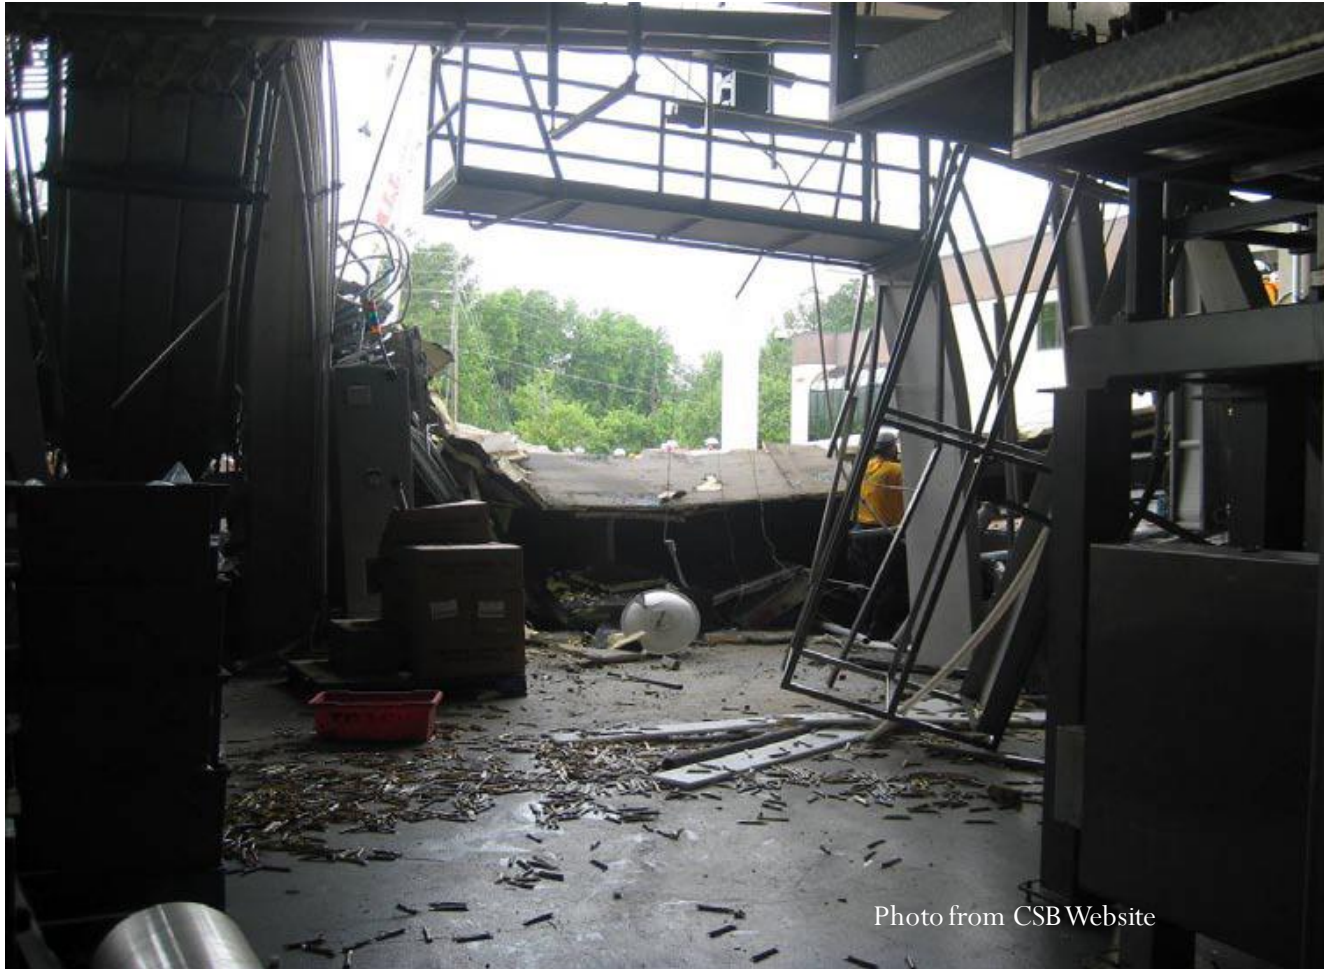
- Explosion/roof collapse killed four people and injured more.
- Explosion also caused a release of anhydrous ammonia.
- Explosion was the result of a *gas purge*, following pressure testing.
- Contract employees believed difficulty starting a new gas water heater was caused by residual air in line.
- Forced natural gas through the pipe, venting into an interior space, over 2 ½ hour span.

# Con Agra Slim Jim Explosion – Gas Purging

- Additional CSB recommendations:
  - Purge gases to a safe location outdoors, away from people and ignition sources.
  - **Limit** indoor purging. If not practicable, then ensure:
    - Non-essential employees are evacuated;
    - Control/eliminate ignition sources;
    - Ventilate sufficiently to maintain concentrations below LEL.
  - Never rely on odor for gas detection.
  - Always use combustible gas monitors during purging.
  - Ensure personnel are trained and knowledgeable.

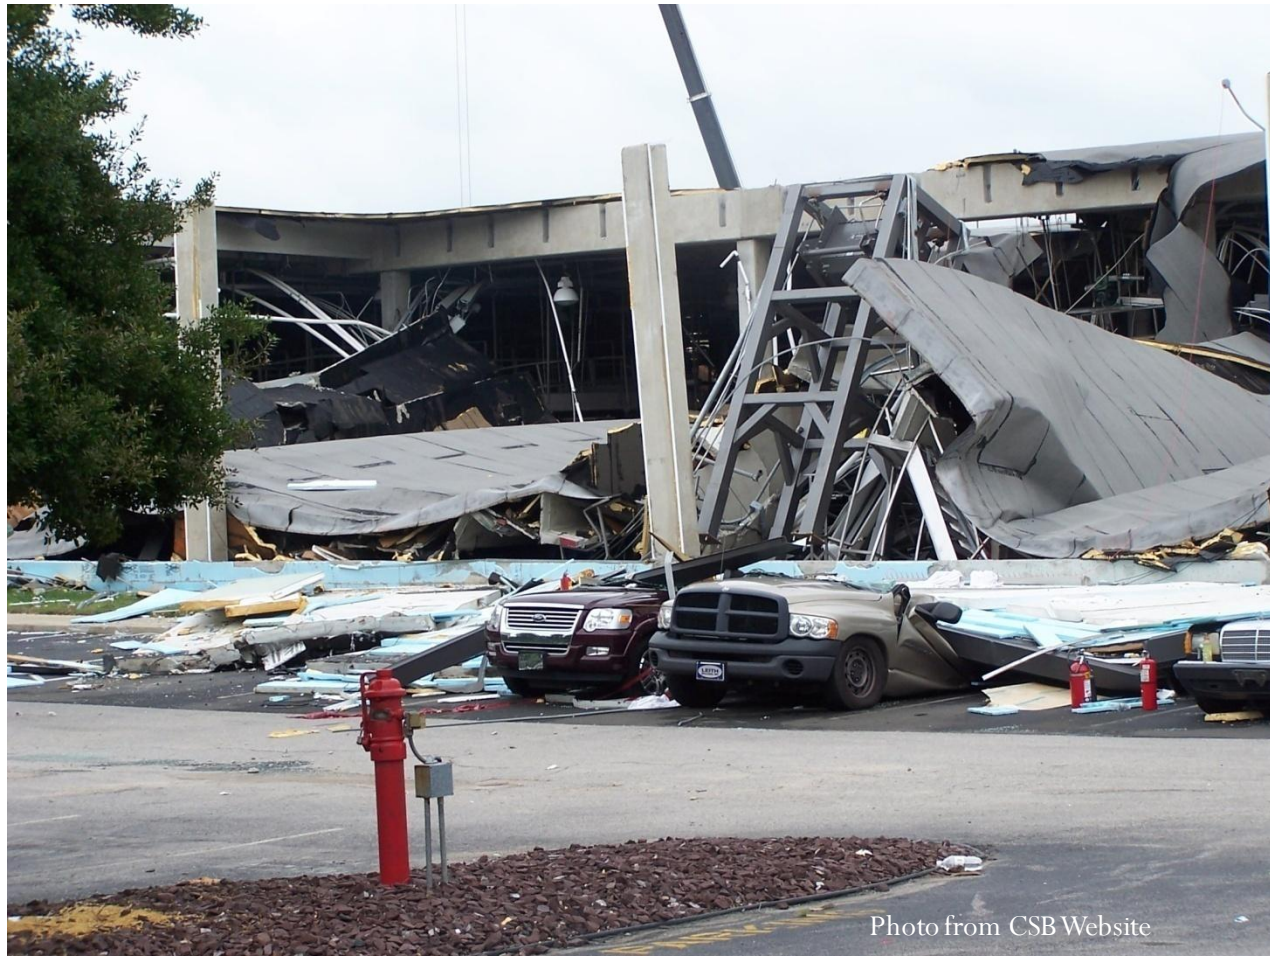
- Combustible gas detectors were *not* in use.
- Non-essential workers were in the area and unaware of the activity.
- Purged gas reached a concentration above the  $\sim 4\%$  lower explosive limit and found ignition source.
- CSB recommended that the NFPA and AGA revise the national fuel gas codes allowing venting indoors. (NFPA has agreed to move forward with CSB recommendations).

# Con Agra Slim Jim Explosion – Gas Purging

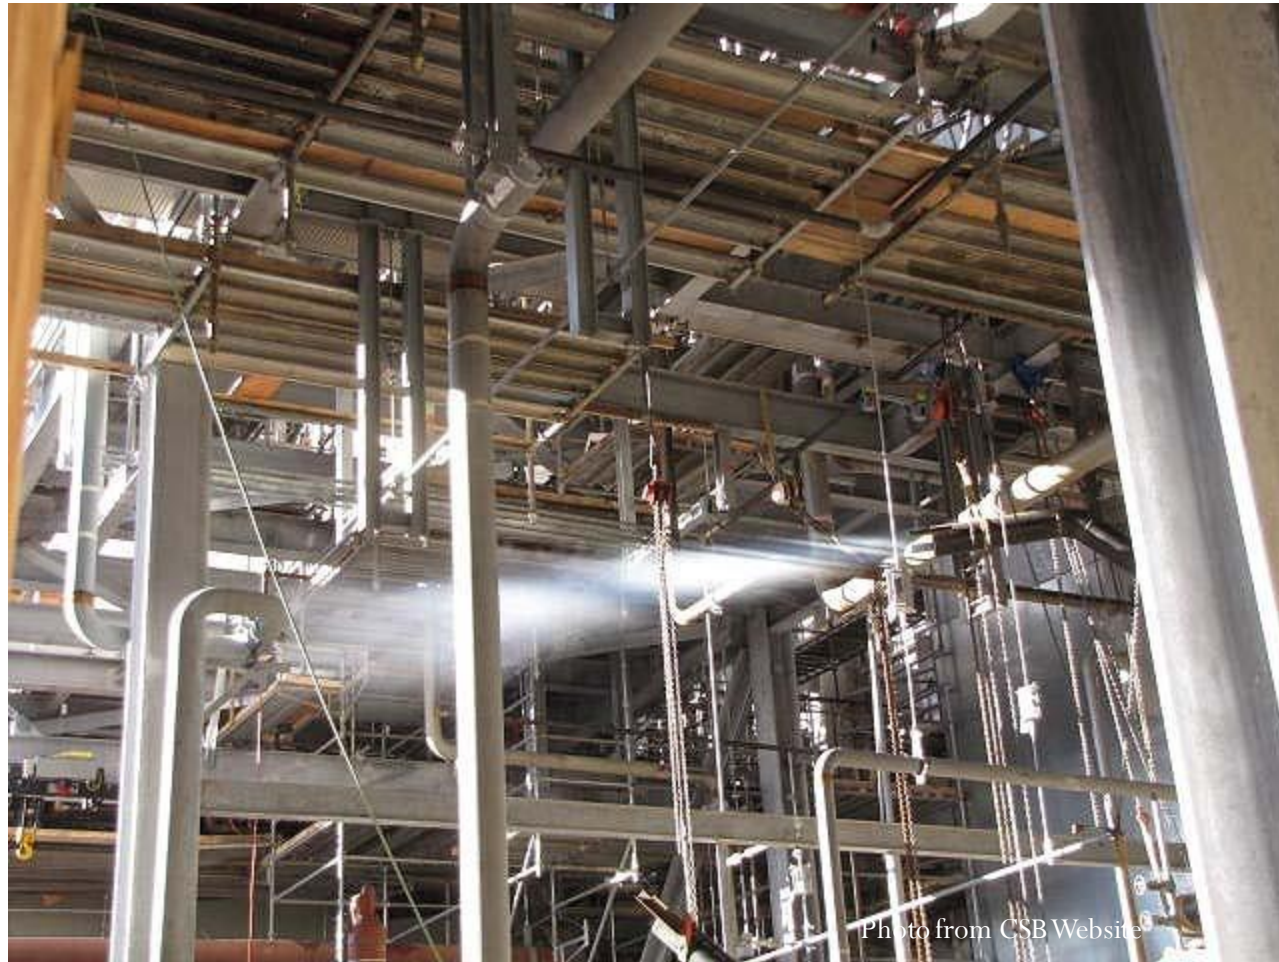
- Explosion was the result of a “gas blow” procedure - high-pressure natural gas forced through piping to remove debris.
- A “common practice” within the gas industry.
- Natural gas at 650 psi was vented at pre-determined locations outside of, but in a congested area next to, power block building.
- Gas monitors were in use (per news article).
- The concentration exceeded the lower explosive limit of ~4% in presence of ignition source.

# Kleen Energy Explosion – Gas Blow

- Explosion killed six workers and injured many more.
- CSB recommends that industry cease the venting of high-pressure flammable gases in or near worksites.
- Possible alternative practices include substitution of air, steam, water or nitrogen for “blowing” or use of combustion devices (such as flares) to safely destroy the flammable gas.
- CSB encourages the gas power industry to strongly consider the “positive actions” of the NFPA and AGA for the national gas codes.

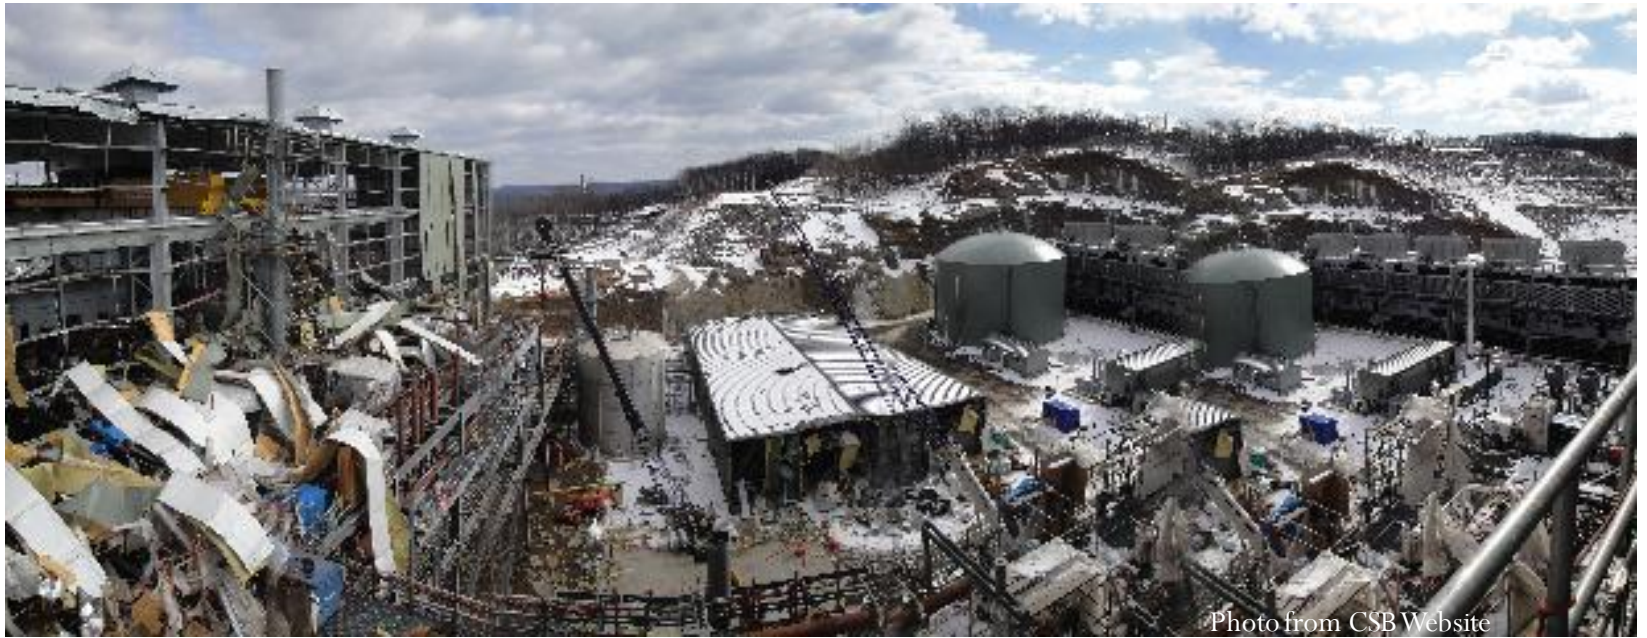
# Kleen Energy Explosion – Gas Blow
