DTE Energy®

Preventing Combustible Dust Incidents, One Utility's Approach

TS Power Plant Silo Explosion

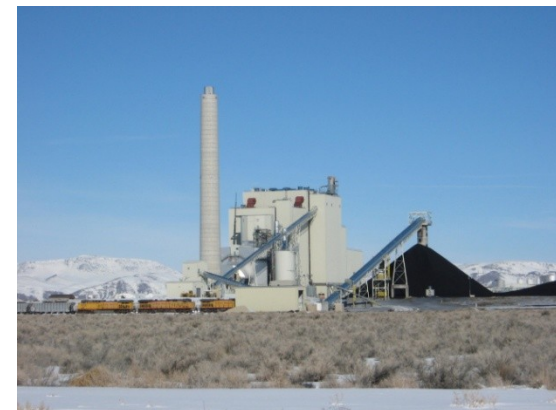
- Located 50 miles West of Elko, Nevada
- PRB coal-fired, 203 MW Net Output
- Plant began Commercial Operation in May 2008
- Unplanned outage began August 6, 2008 due to unstable main flame detection
- Maintenance and problems with “A” coal feeder delayed start-up attempt until August 16th

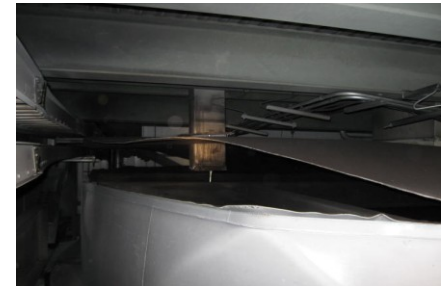
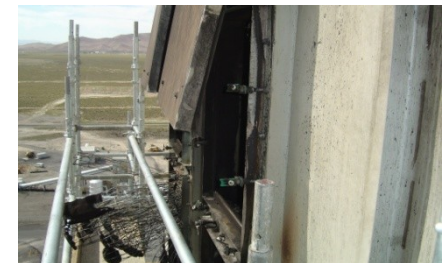
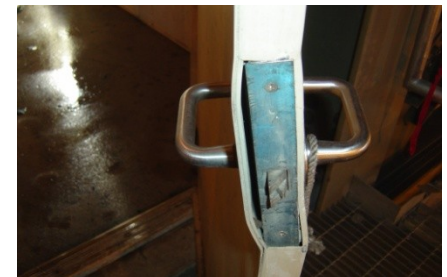
- Explosion and Fire Damage
 - Roof of Silo “A” torn open
 - Overpressure damage to Silos “B” and “C”
 - Overpressure damage to Dust Collector
 - Explosion/Flash Fire in Dust Collector
 - Overpressure damage to Tripper Room, doors, fans and fire system
 - Fire damage to electrical wiring

- Corrective Actions/Lessons Learned
 - Define PRB Coal holding times
 - Monitoring of PRB Coal in silos (CO & Thermal Imaging)
 - Communication
 - Internal fire suppression in silos / silo wash-down system
 - Develop “Best Practice” fire suppression system / fire fighting methods
 - Additional fire training / fire suppression
 - Silo isolation
 - Explosion diversion
 - Improve methods of emptying PRB Coal from silos
 - Fire Resistant (FR) clothing
